Autumn/Winter 1995. It's engine and gearbox time!

Ged Rumble

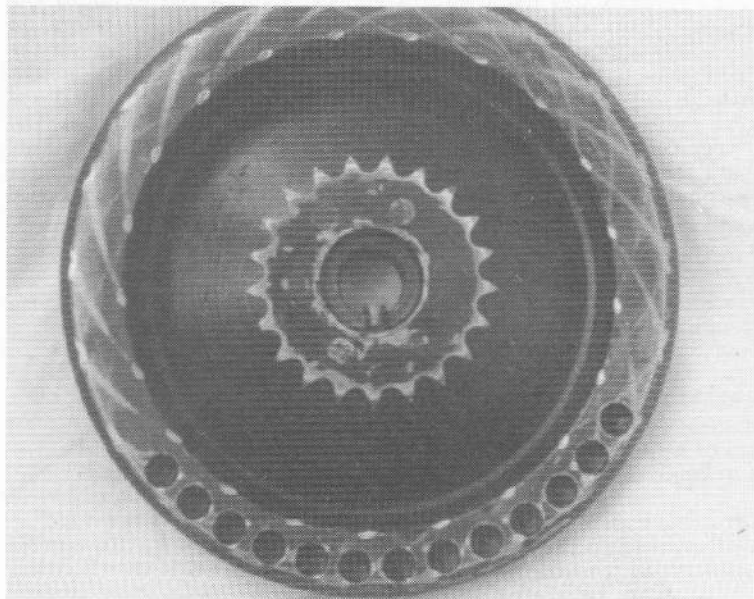
Now to that awful noise. This was caused by the chain pins thrashing around against the flywheel. The pins were carving a cross-hatch pattern across the side face of the flywheel (see photo). The engine and clutch sprockets were 0.070" out of line the wrong way (see photo. The shot is exaggerated to make the error more obvious).

Cross-hatching pattern on flywheel (above) caused by misalignment (below).

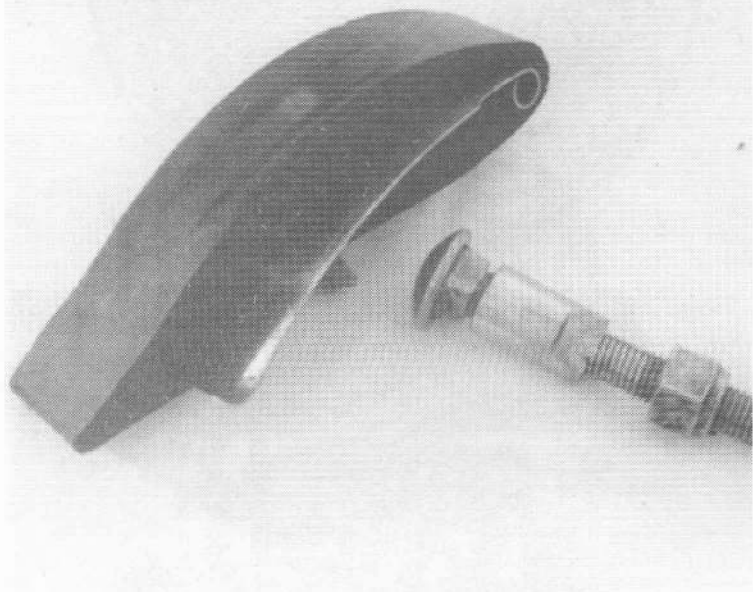
The gearbox has fixed centres and can't be moved to adjust the primary chain, as I believe some Silk Scott boxes can. Therefore, an adjustable slipper is used to take up the chain slack. It fits on the chain guide in the crankcase, and is adjusted by a screw arrangement through the crankcase base. This assembly, !?!, was an awful piece of work made by Bodgit & Scarper Engineering by the look of it. The slipper consisted of a piece chopped out of an Austin Maxi timing chain tensioner, or so I'm led to believe by local V.M.C.C. members (see photo). The nitrile rubber was not bonded to the steel, and moved about all over the place.

Another classic piece of engineering from Bodgits was the adjusting device. It was a piece of $\frac{9}{16}$ " dia. bar, $\frac{1}{8}$ " long, drilled through $\frac{3}{8}$ " dia. In one end was hammered the head of a $\frac{3}{8}$ " coach bolt, in the other end was the adjusting screw. This was a piece of $\frac{3}{8}$ " BSF all thread, with the threads ground off so it would revolve easily in the hole, and a couple of spanner flats on the end. A flat was ground on the $\frac{9}{16}$ " bar to fit against the end of the chain guide to stop this assembly(!) revolving when the adjusting screw was turned. The whole assembly was very flimsy and when it was used the primary chain was pushed even harder into the flywheel, and the noise increased two-fold.

A new and more substantial bracket was made and welded to the chain guide. A Triumph slipper was modified to suit the job in hand. The result is a solid job on which the chain runs without any sideways drift. I have it in mind to do this mod to my 1931 Flyer when I next have the engine out (see sketch).

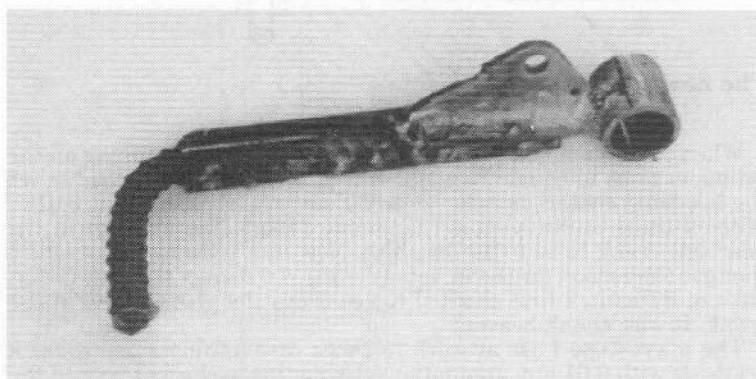
Now for the foot-brake pedal. The original wasn't genuine Bogits this time. It was made in Kenya by a witch doctor's apprentice, using a piece of tube with a bronze bush, $\frac{1}{2}$ " x $\frac{1}{2}$ " angle iron and six inches of $\frac{3}{8}$ " construction rod (see photo). A new Silk 700S alloy pedal was obtained from Clive Worrall. After machining it fits a treat, the right length in a perfect position.

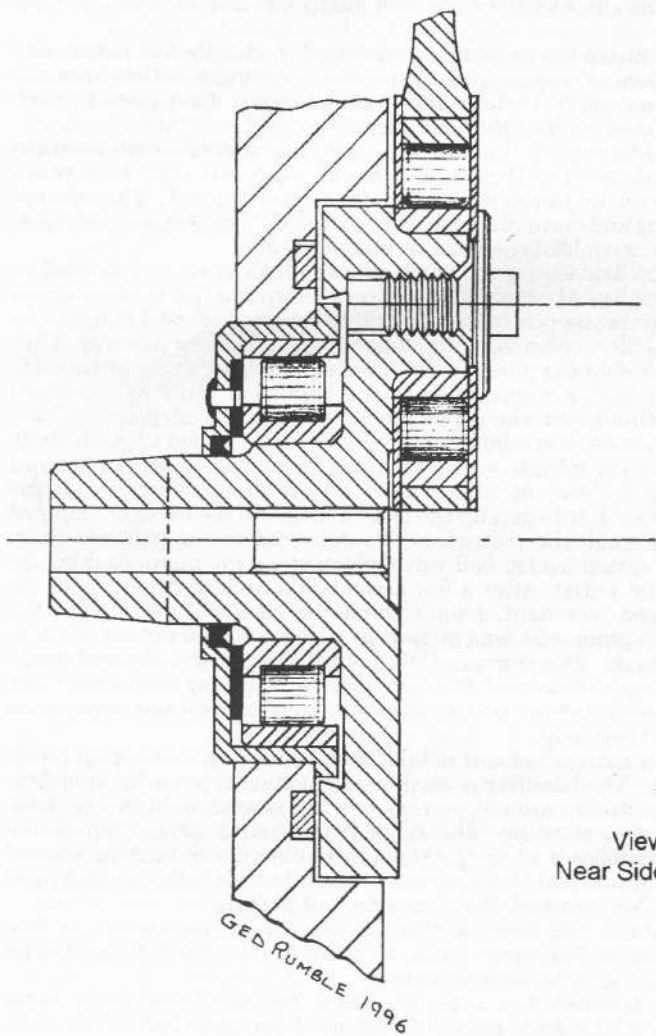
23rd Silk-Scott Crank Assembly

crank apart from the exploded view on page 2.3.18, which isn't very explicit. So here is my cross-section drawing of the crank assembly of my engine. It may be different to cranks in other Silk Scott engines, what with George and his mates experimenting all the time. The crank disc is 4" diameter and $\frac{1}{2}$ " thick at its outer edge. The crankpin is $\frac{13}{16}$ " diameter and has a $\frac{3}{8}$ " BSF tapped hole, rather than $\frac{1}{2}$ " like the Scott. This all adds strength.

Substantial machining of the crankcase had to take place to enable these cranks to be fitted. The main bearing is a metric roller race No. N206. The thrust races are bi-metal, with one face Oilite bronze, Glacier Metal No. DU18D. The oil seals are Barnwell 1.25—1.00—0.12.
